Rocky Flats Environmental Technology Site

RECONNAISSANCE LEVEL CHARACTERIZATION REPORT (RLCR) SUPPLEMENT

771 CLOSURE PROJECT

REVISION 0

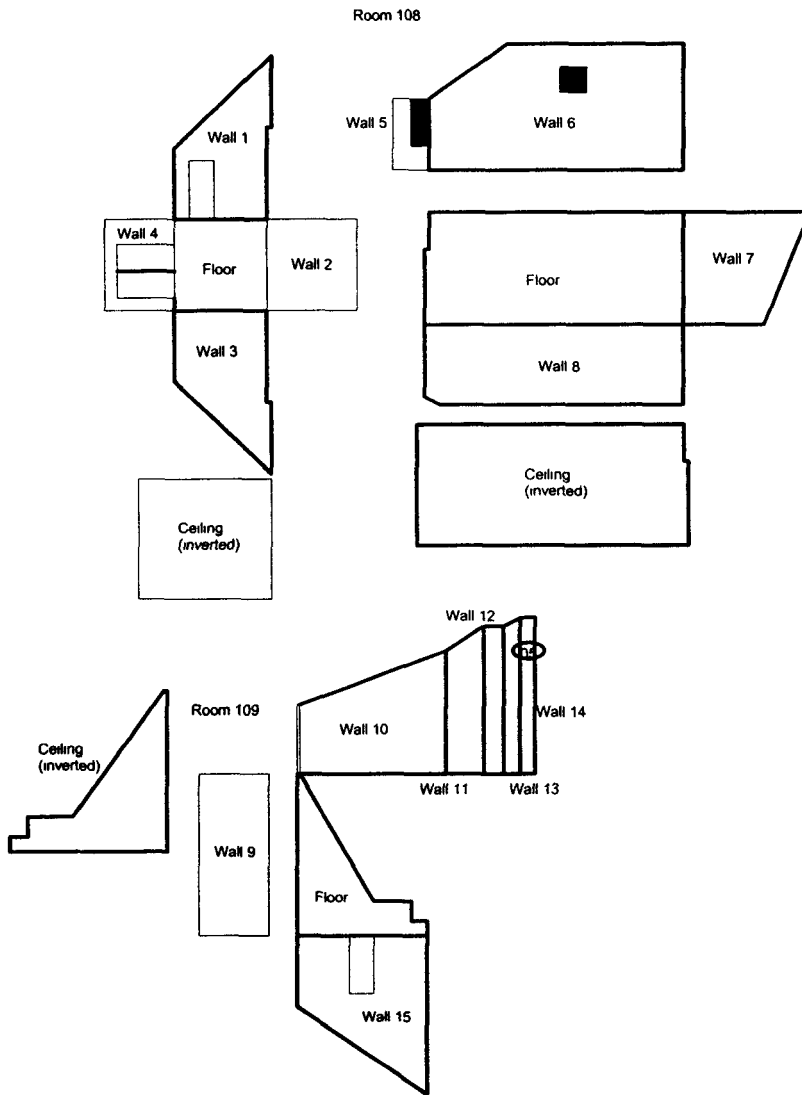
SURVEY UNIT 771022 - MAP 2 OF 5

Survey Area AJ Survey Unit 771022 Classification 3
 Building 8790
 Survey Unit Description Interior
 Total Floor Area 501 sq m Total Area 2473 sq m Grid Size N/A

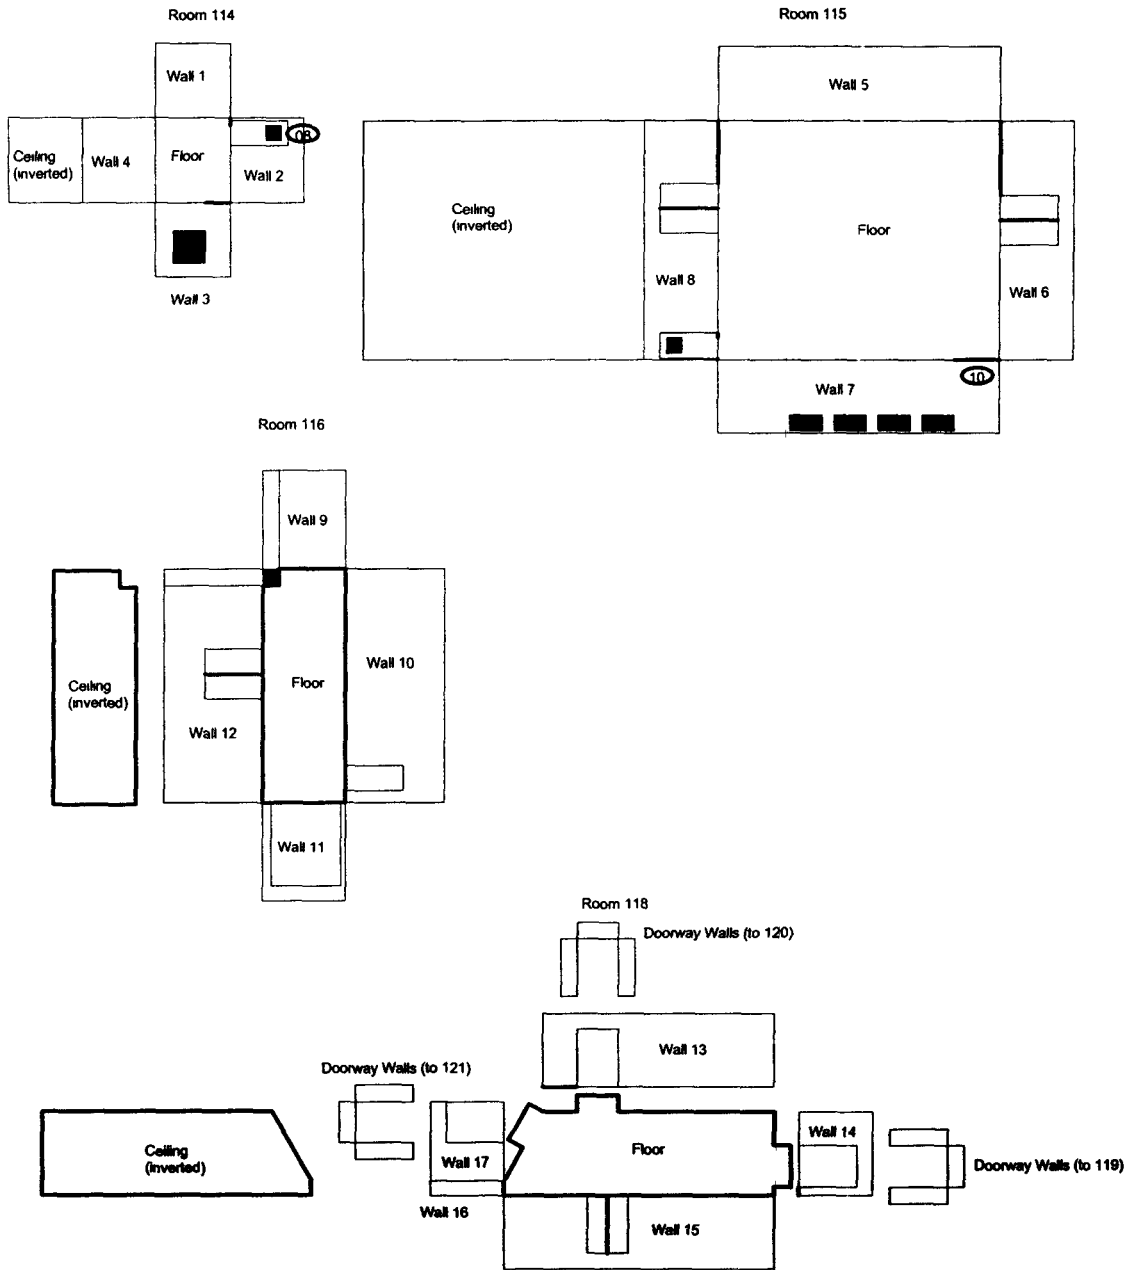
SURVEY UNIT 771022 - MAP 3 OF 5

Survey Area AJ Survey Unit. 771022 Classification 3
 Building B790
 Survey Unit Description Interior
 Total Floor Area 501 sq m Total Area 2473 sq m Grid Size N/A

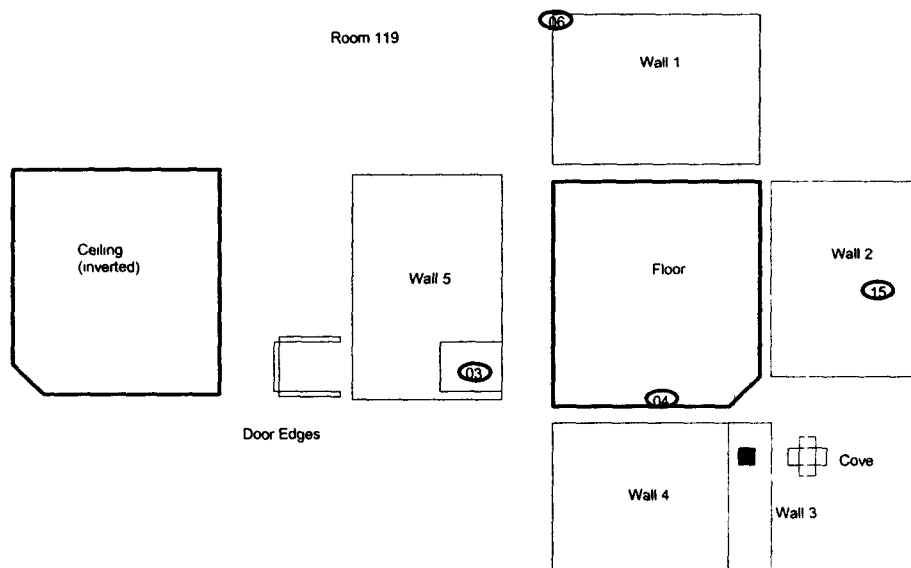
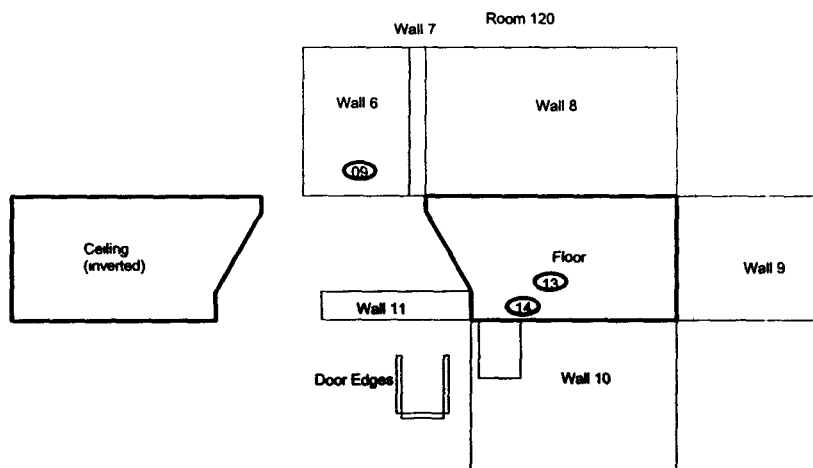
SURVEY UNIT 771022 - MAP 4 OF 5

Survey Area AJ Survey Unit 771022 Classification 3
 Building B790
 Survey Unit Description Interior
 Total Floor Area 501 sq m Total Area 2473 sq m Grid Size N/A

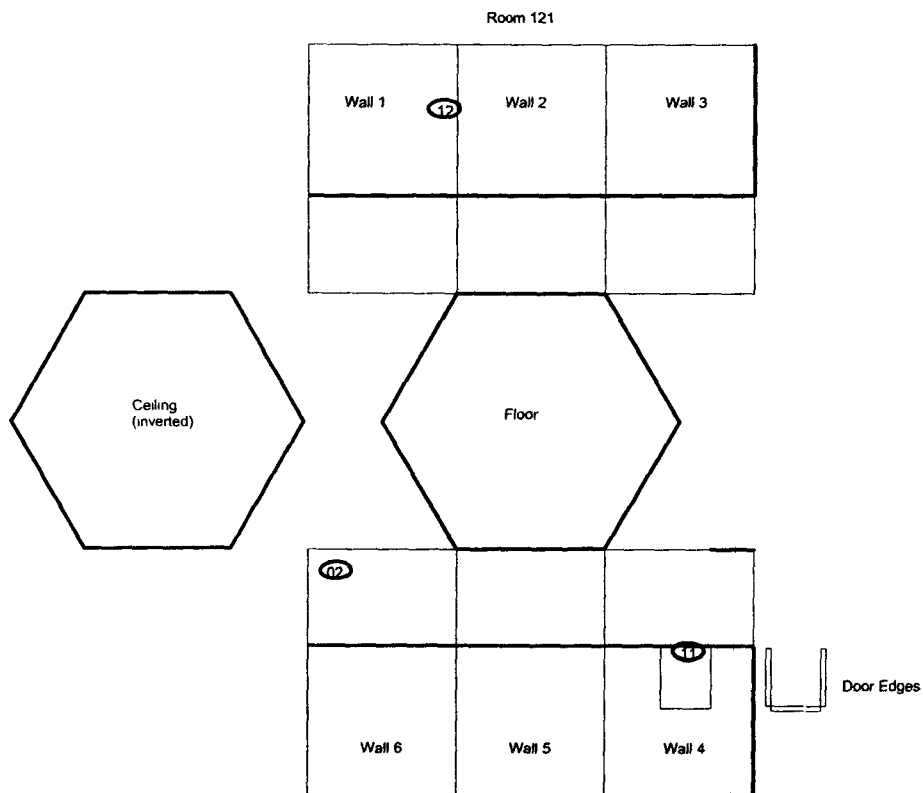
SURVEY UNIT 771022 - MAP 5 OF 5

Survey Area AJ Survey Unit 771022 Classification 3
 Building B790
 Survey Unit Description Interior
 Total Floor Area 501 sq m Total Area 2473 sq m Grid Size N/A

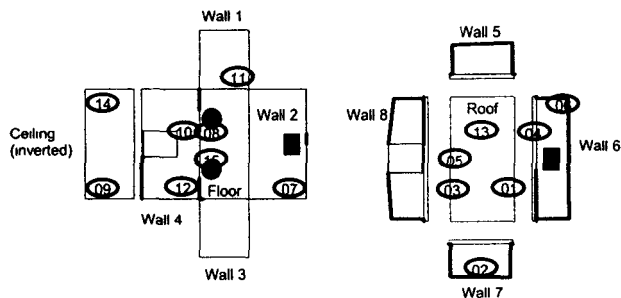
SURVEY UNIT 771023 - MAP 1 OF 1

Survey Area AJ Survey Unit 771023 Classification 2
 Building B728
 Survey Unit Description Exterior/Interior
 Total Floor Area 7 sq m Total Area 67 sq m Grid Size N/A

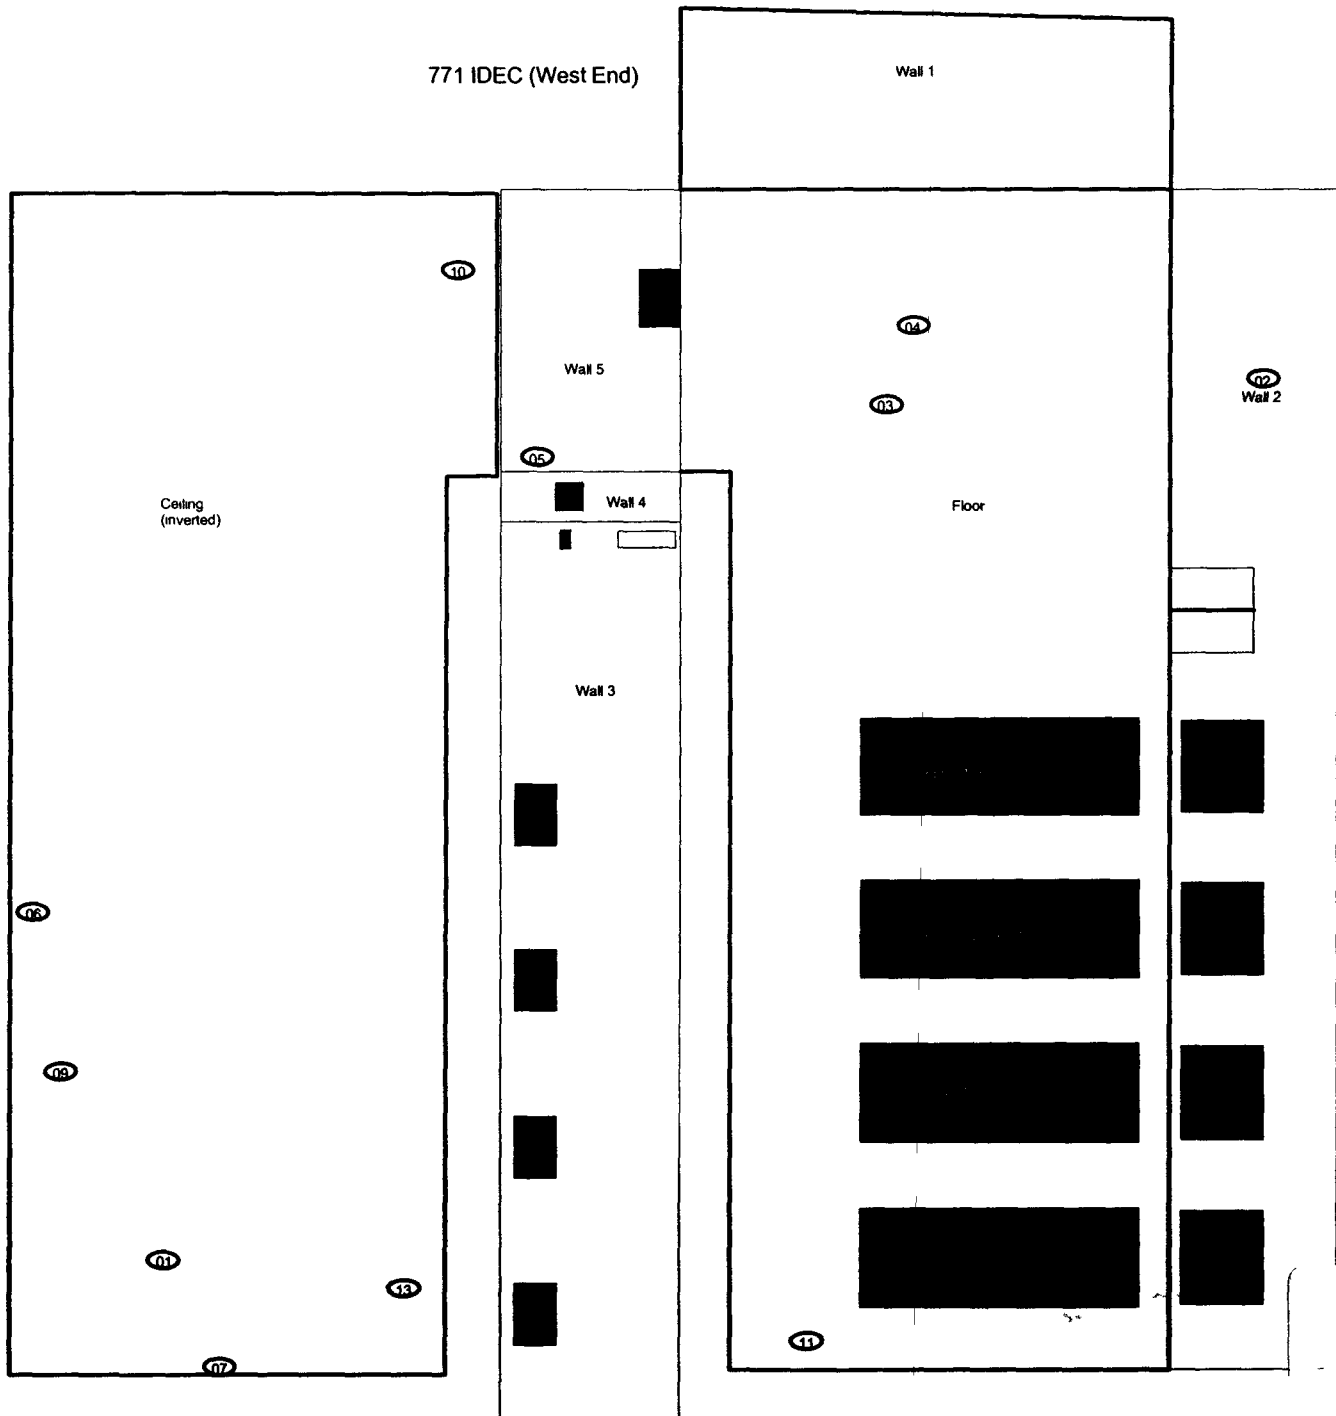
SURVEY UNIT 771026 - MAP 1 OF 2

Survey Area AI Survey Unit: 771026 Classification 3
 Building 771
 Survey Unit Description IDEC (West end) Interior
 Total Floor Area 616 sq m Total Area 2256 sq m Grid Size N/A

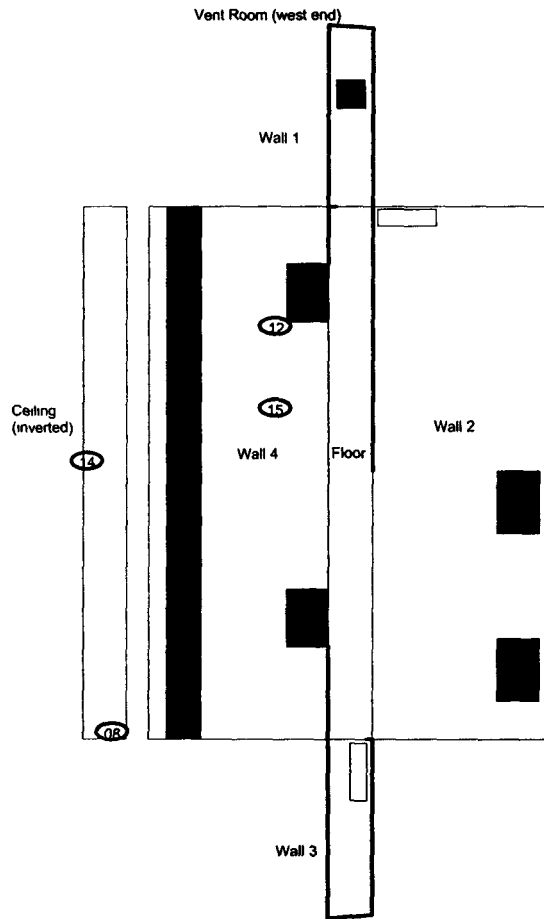
SURVEY UNIT 771026 - MAP 2 OF 2

Survey Area AI Survey Unit. 771026 Classification 3
Building 771
Survey Unit Description IDEC (West end) Interior
Total Floor Area 616 sq m Total Area 2256 sq m Grid Size N/A

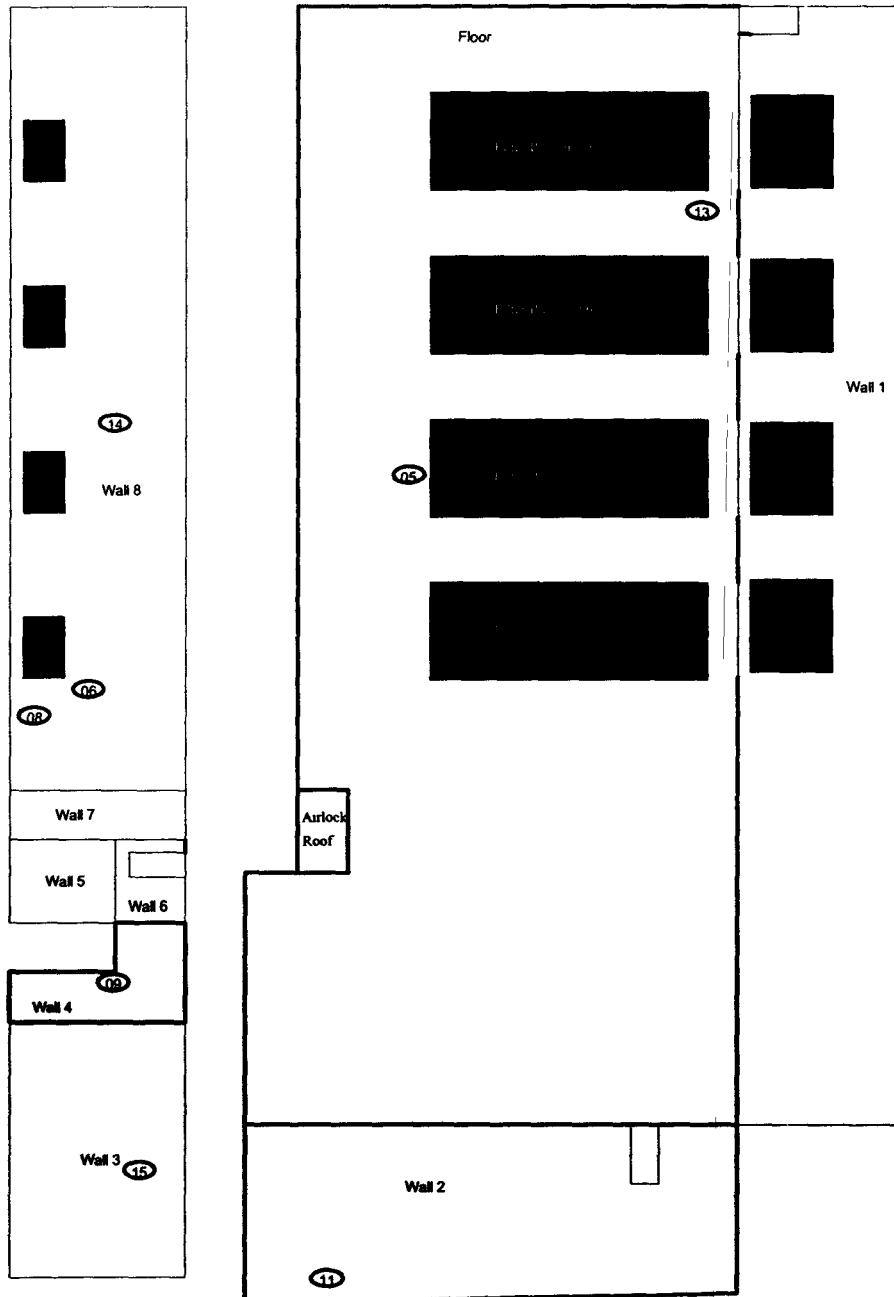
SURVEY UNIT 771027 - MAP 1 OF 2

Survey Area AI Survey Unit: 771027 Classification 3
Building 771
Survey Unit Description IDEC (East end) Interior
Total Floor Area 584 sq. m Total Area 2058 sq. m Grid Size N/A

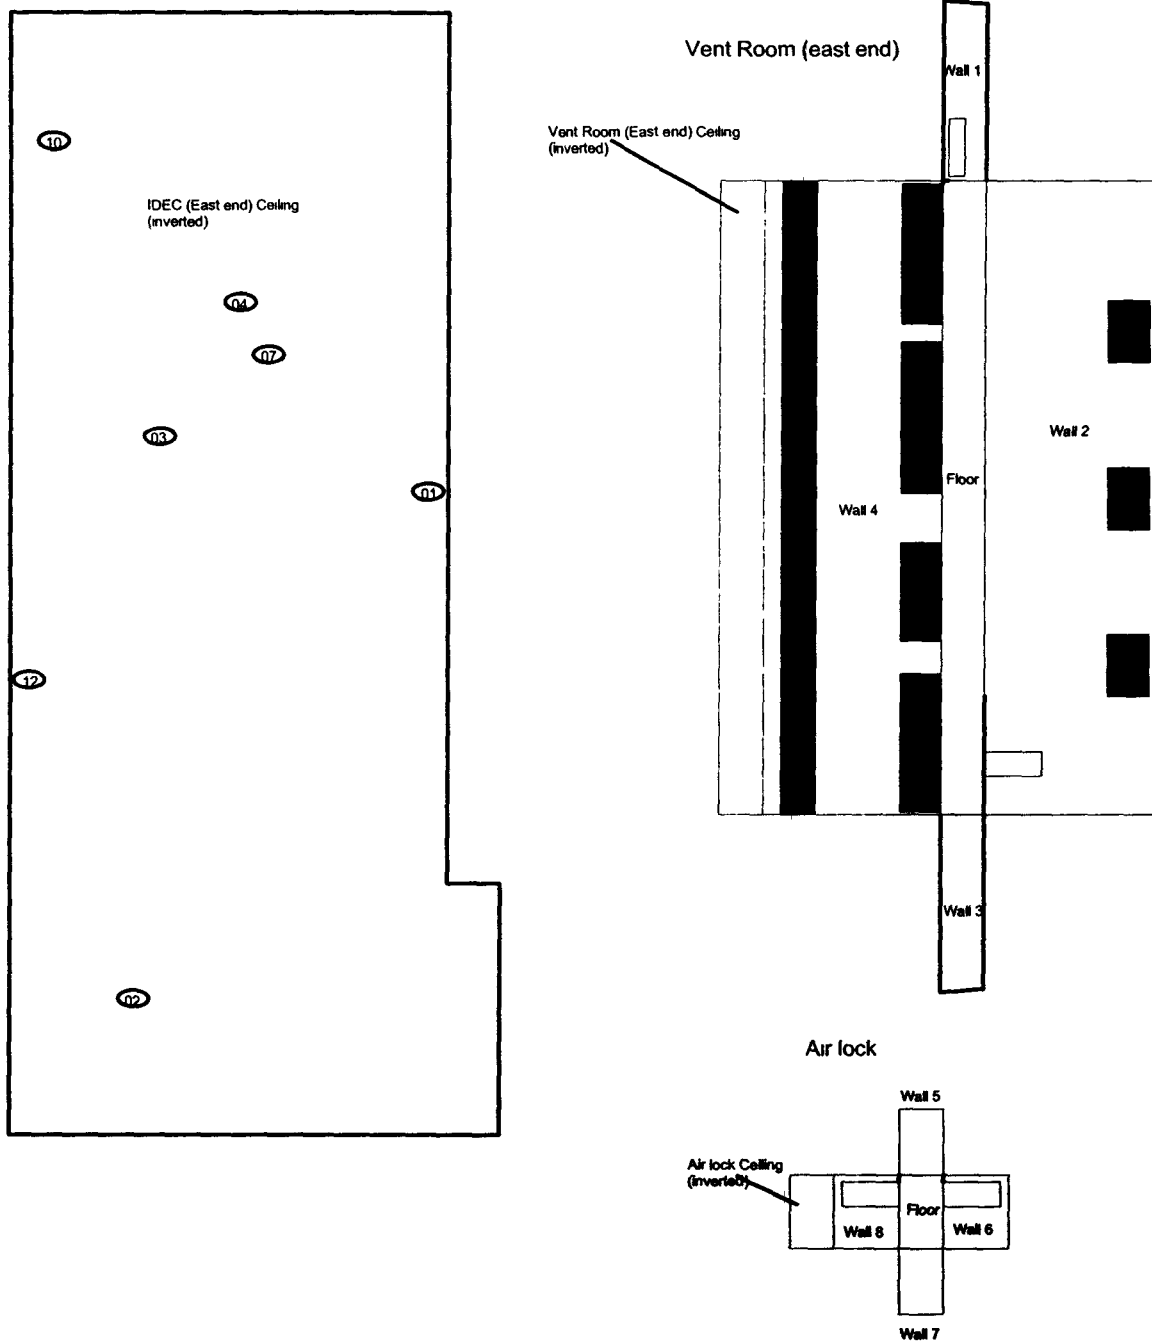
SURVEY UNIT 771027 - MAP 2 OF 2

Survey Area AI Survey Unit: 771027 Classification 3
 Building 771
 Survey Unit Description IDEC (East end) Interior
 Total Floor Area 584 sq m Total Area 2058 sq m Grid Size N/A

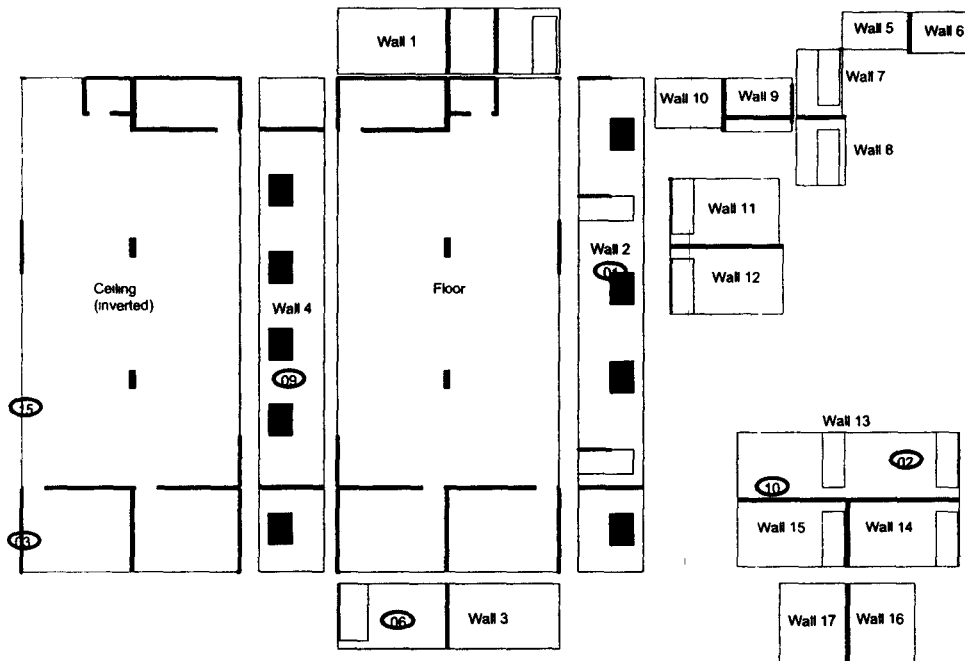
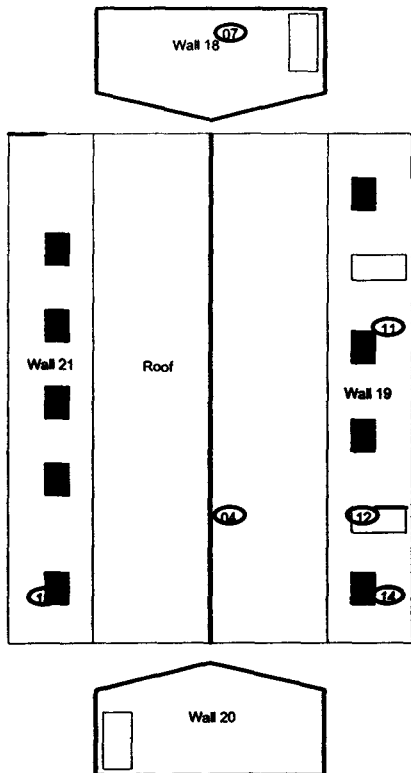
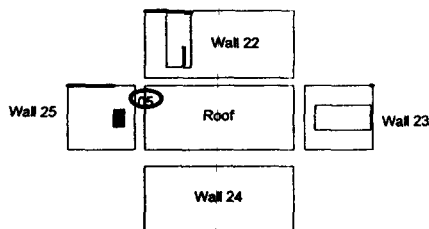
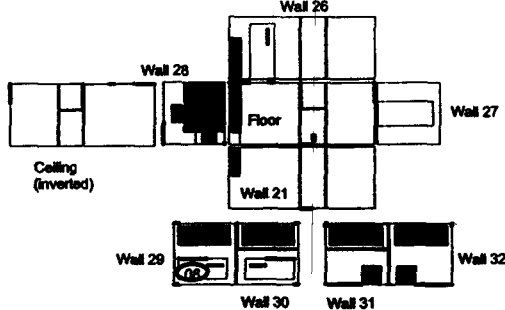
SURVEY UNIT 771030 - MAP 1 OF 1

T771R Interior

T771R Exterior

T771DT Exterior

T771DT Interior

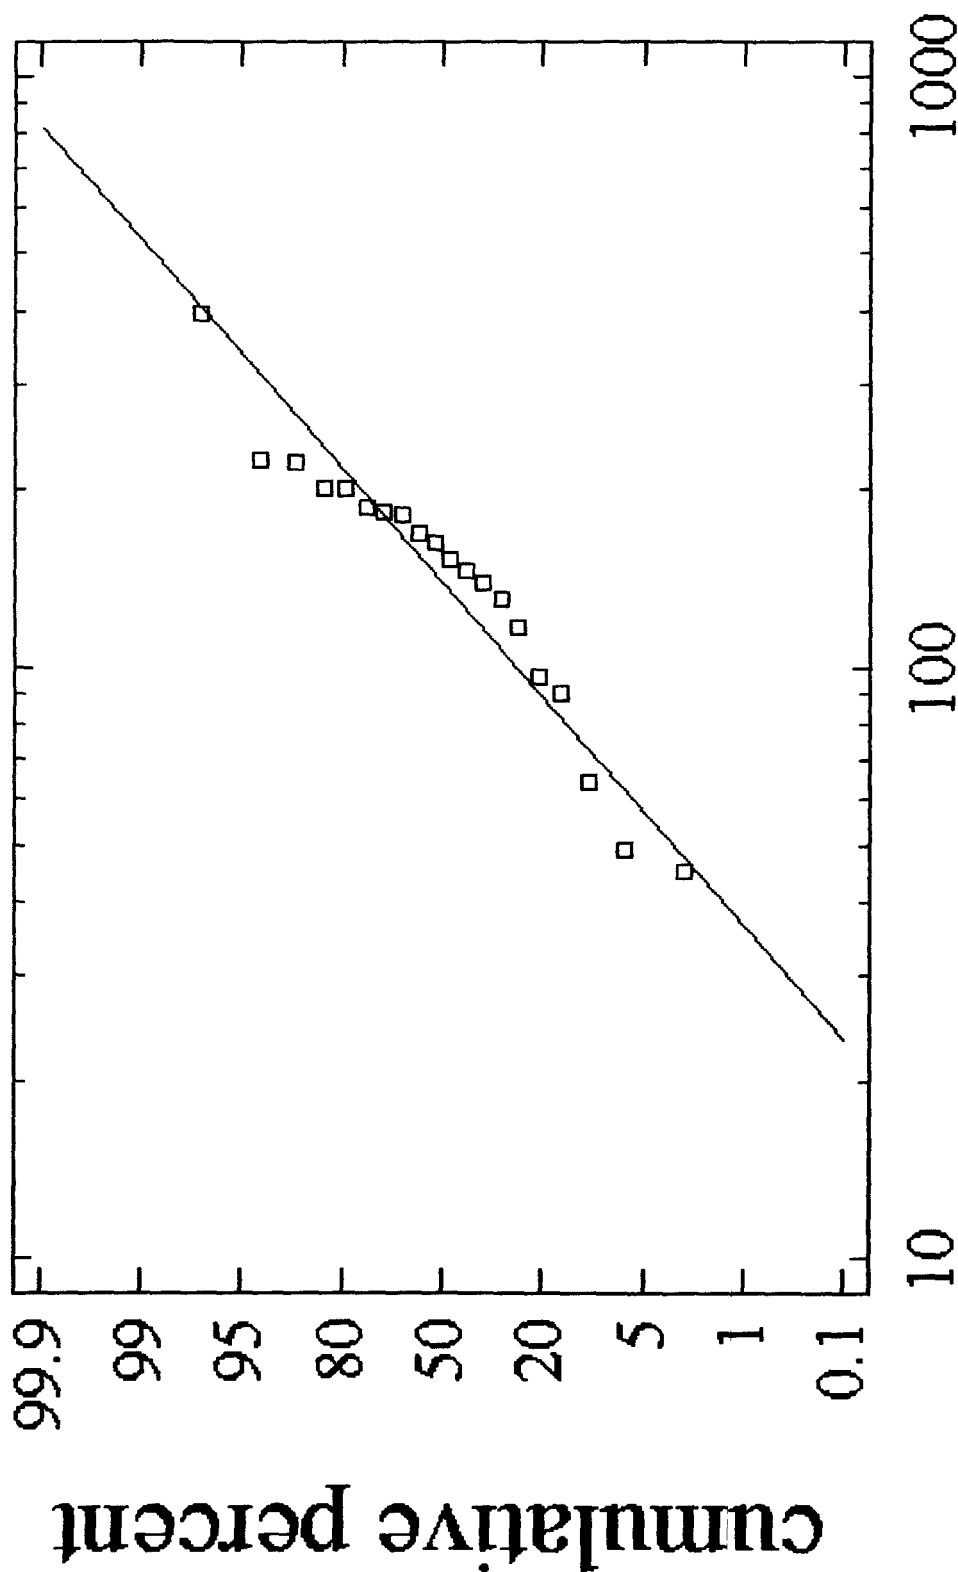
Lognormal Probability Plot

Survey Unit 779011 dpm

Since the smallest P-value amongst the tests performed is greater than or equal to 0.10, we can not reject the idea that Survey Unit 779011 dpm comes from a lognormal distribution with 90% or higher confidence.

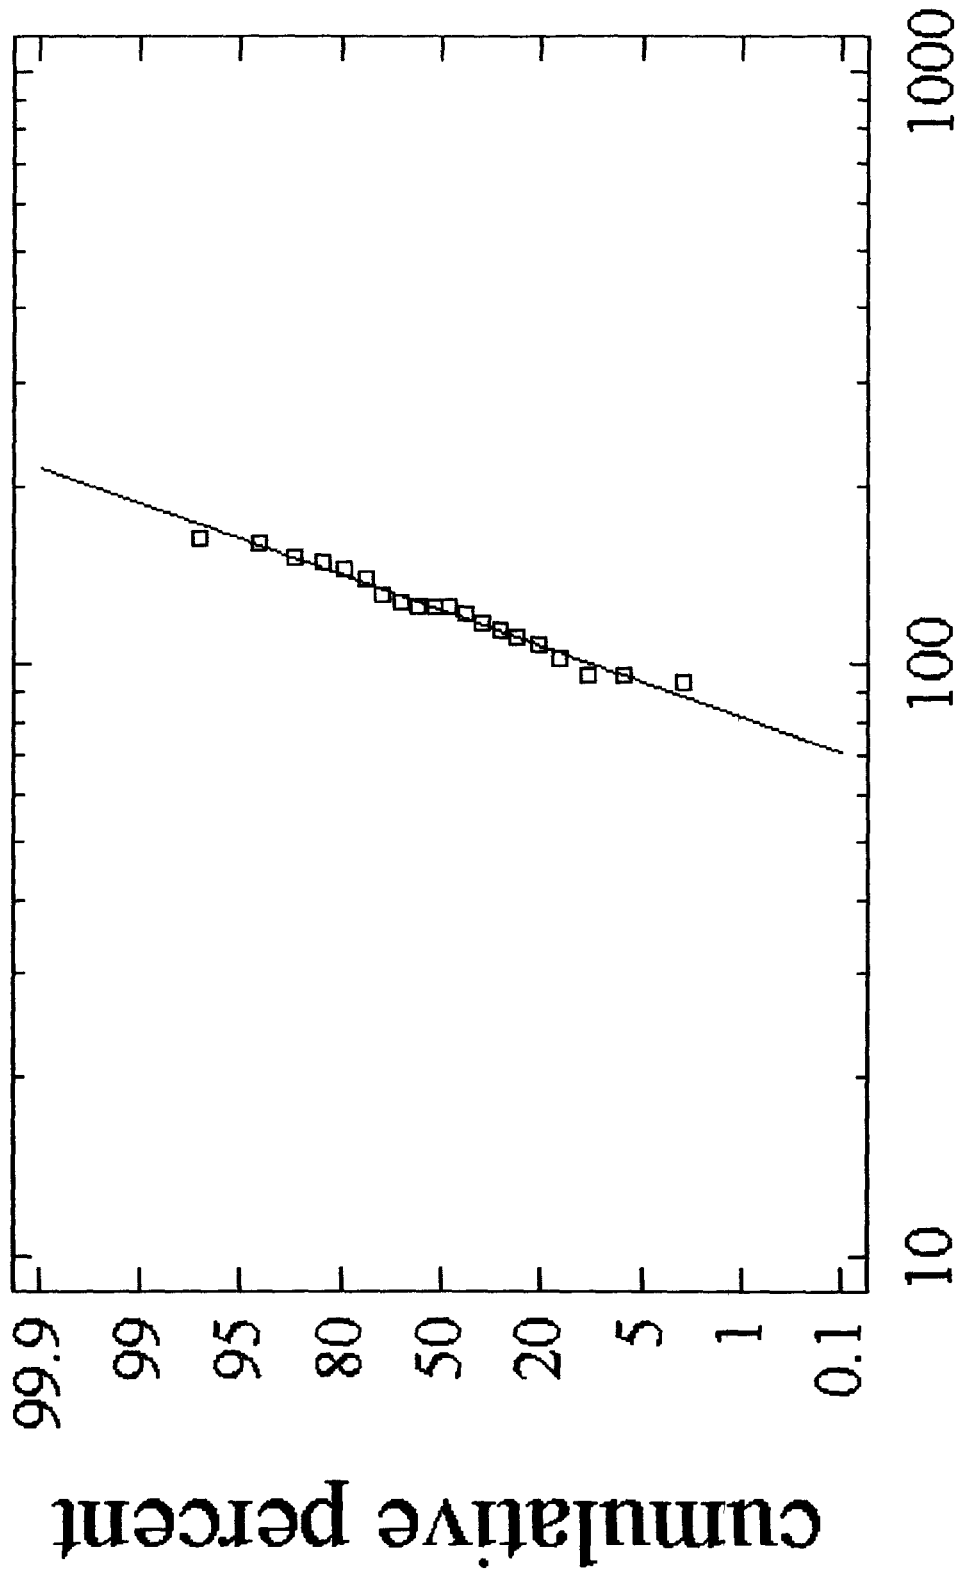
Lognormal Probability Plot

Survey Unit 779012 dpm

Since the smallest P-value amongst the tests performed is greater than or equal to 0.10, we can not reject the idea that Survey Unit 779012 dpm comes from a lognormal distribution with 90% or higher confidence.

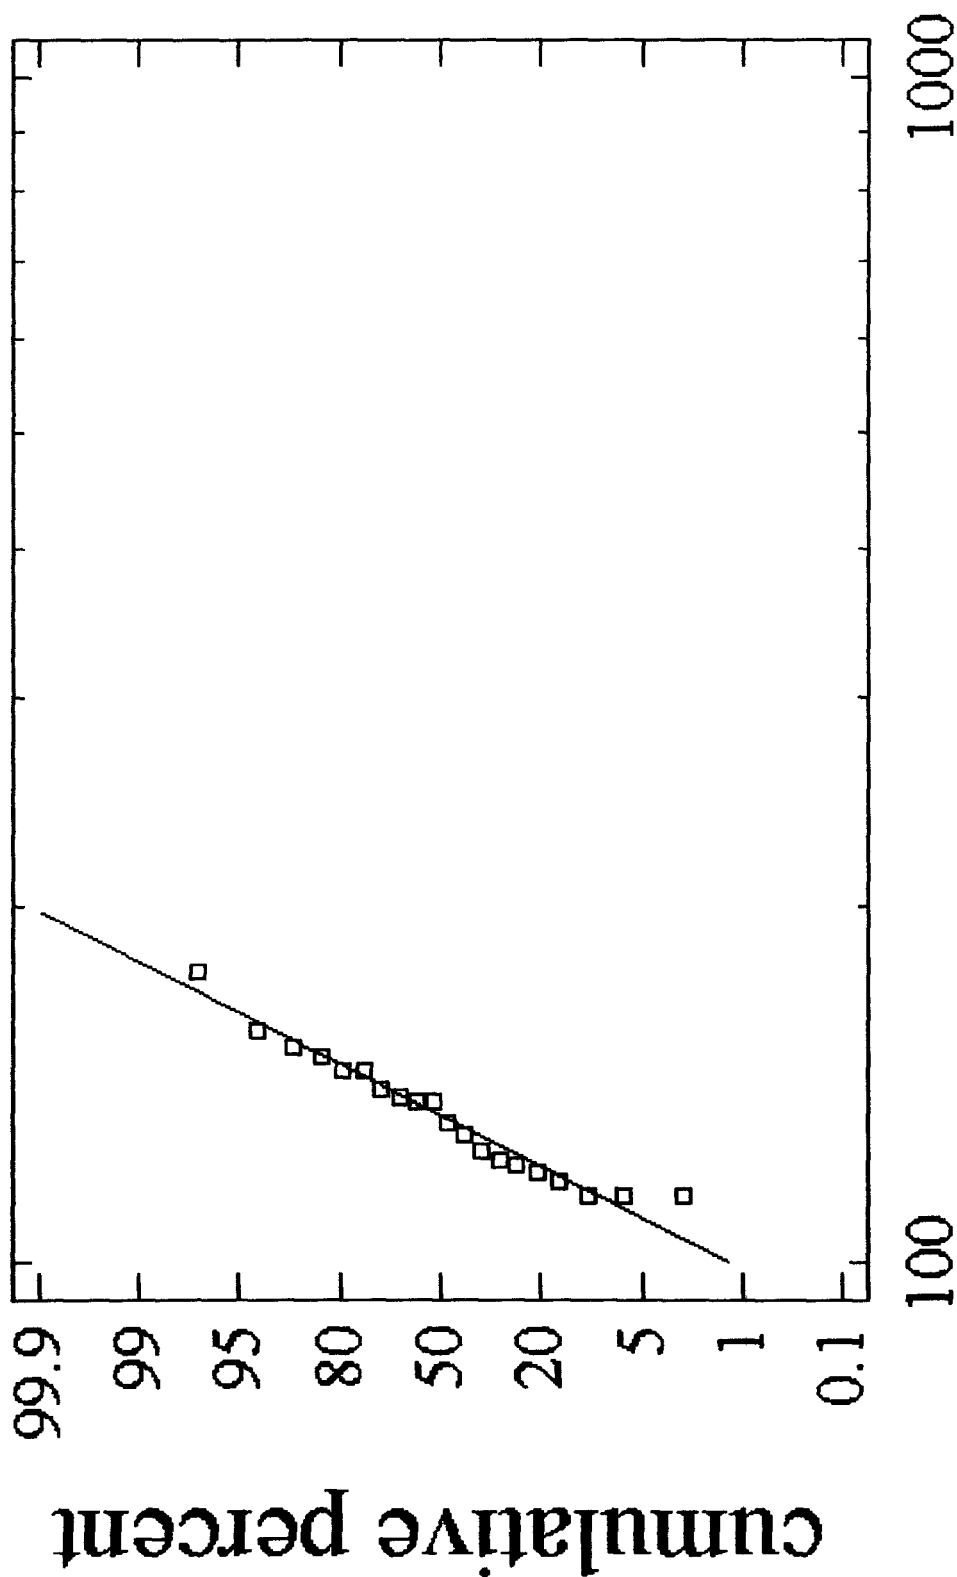
Lognormal Probability Plot

Survey Unit 779013 dpm

Since the smallest p-value amongst the tests performed is greater than or equal to 0.10, we can not reject the idea that Survey Unit 779013 dpm comes from a lognormal distribution with 90% or higher confidence.

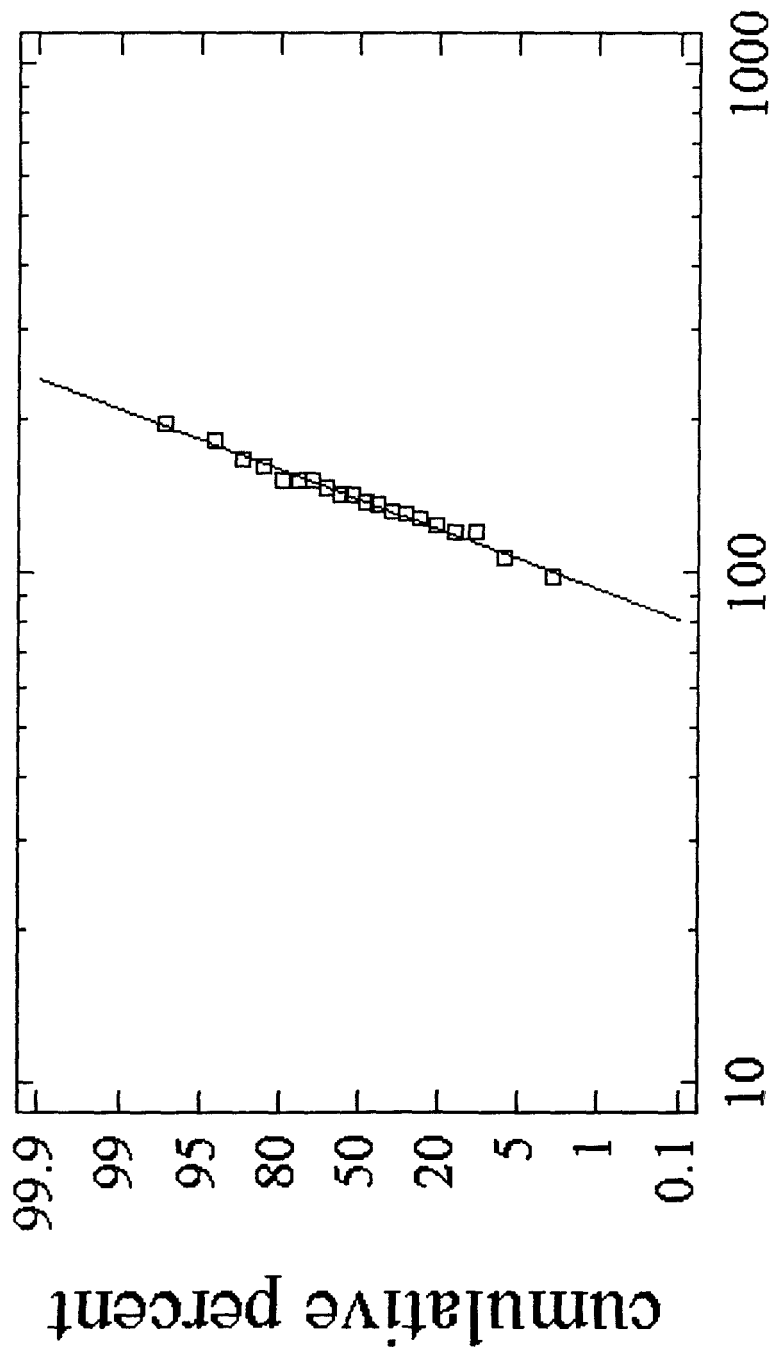
Lognormal Probability Plot

Survey Unit 779014 dpm

Since the smallest P-value amongst the tests performed is greater than or equal to 0.10, we can not reject the idea that Survey Unit 779014 dpm comes from a lognormal distribution with 90% or higher confidence.

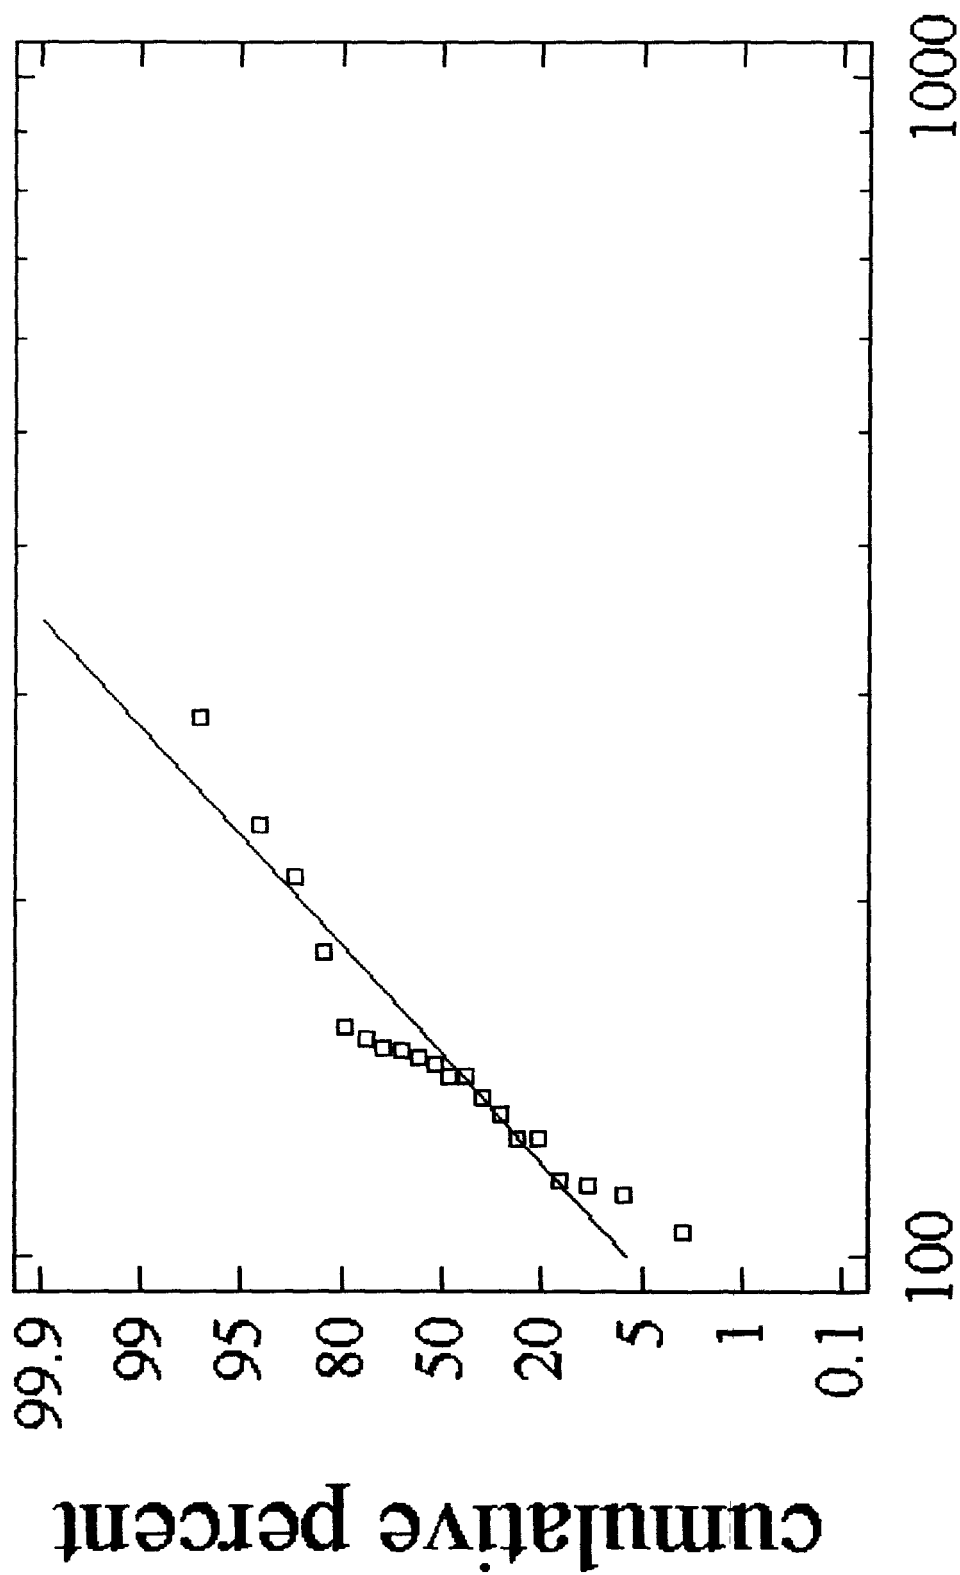
Lognormal Probability Plot

Survey Unit 779016 dpm

Since the smallest P-value amongst the tests performed is less than 0.10, we can reject the idea that Survey Unit 779016 dpm comes from a lognormal distribution with 90% confidence.

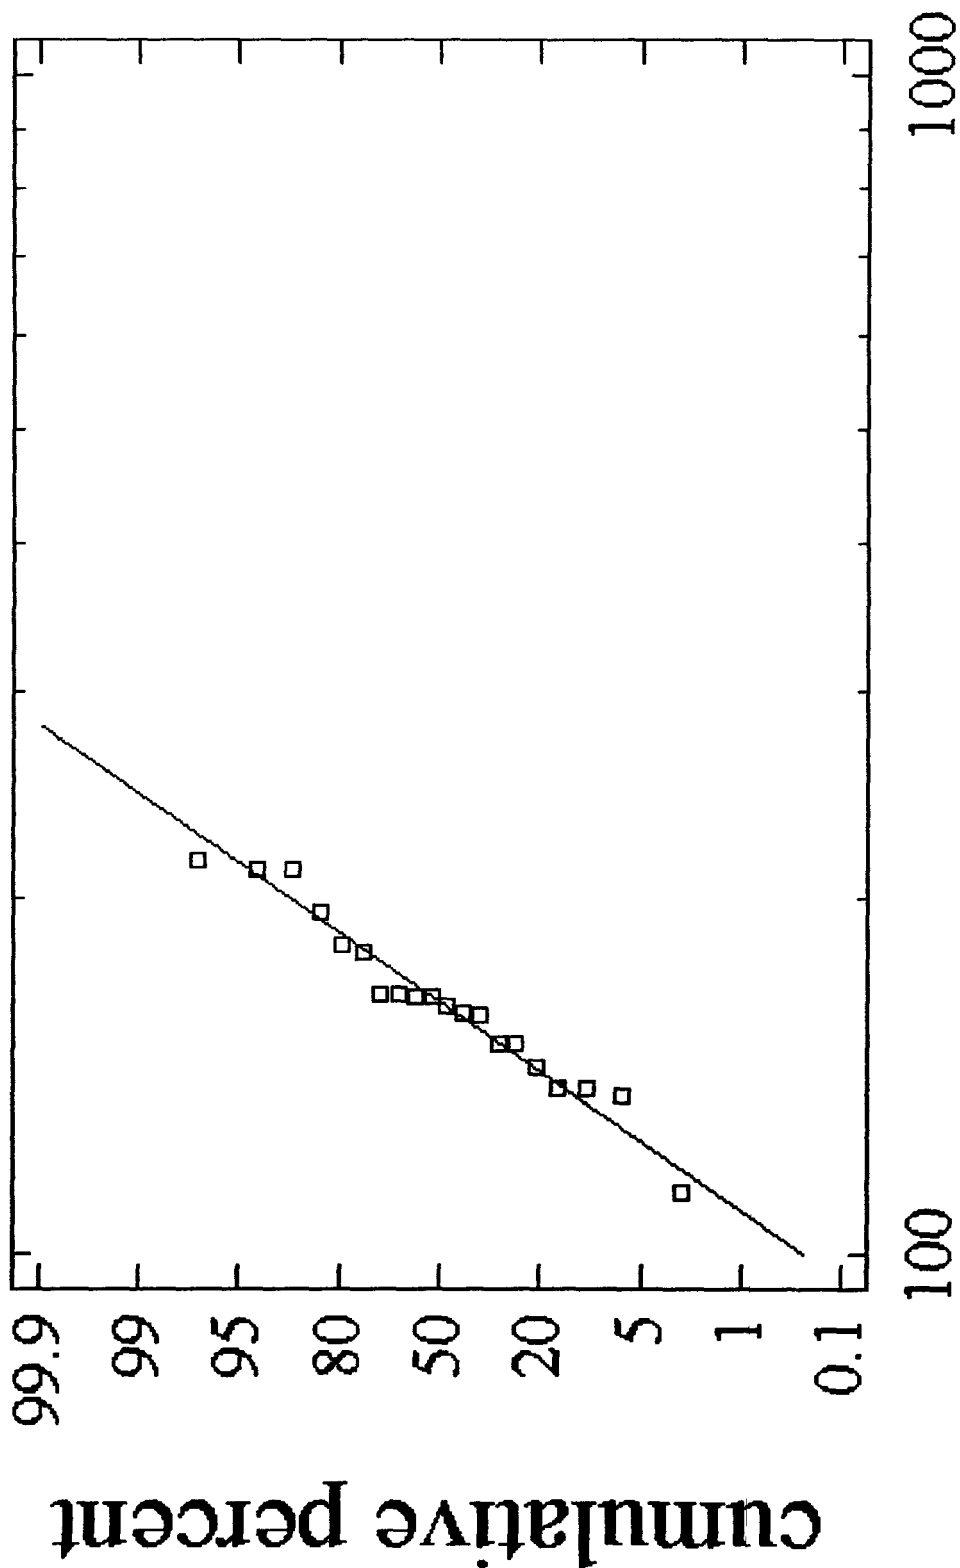
Lognormal Probability Plot

Survey Unit 779017 dpm

Since the smallest P-value amongst the tests performed is less than 0.10, we can reject the idea that Survey Unit 779017 dpm comes from a lognormal distribution with 90% confidence.

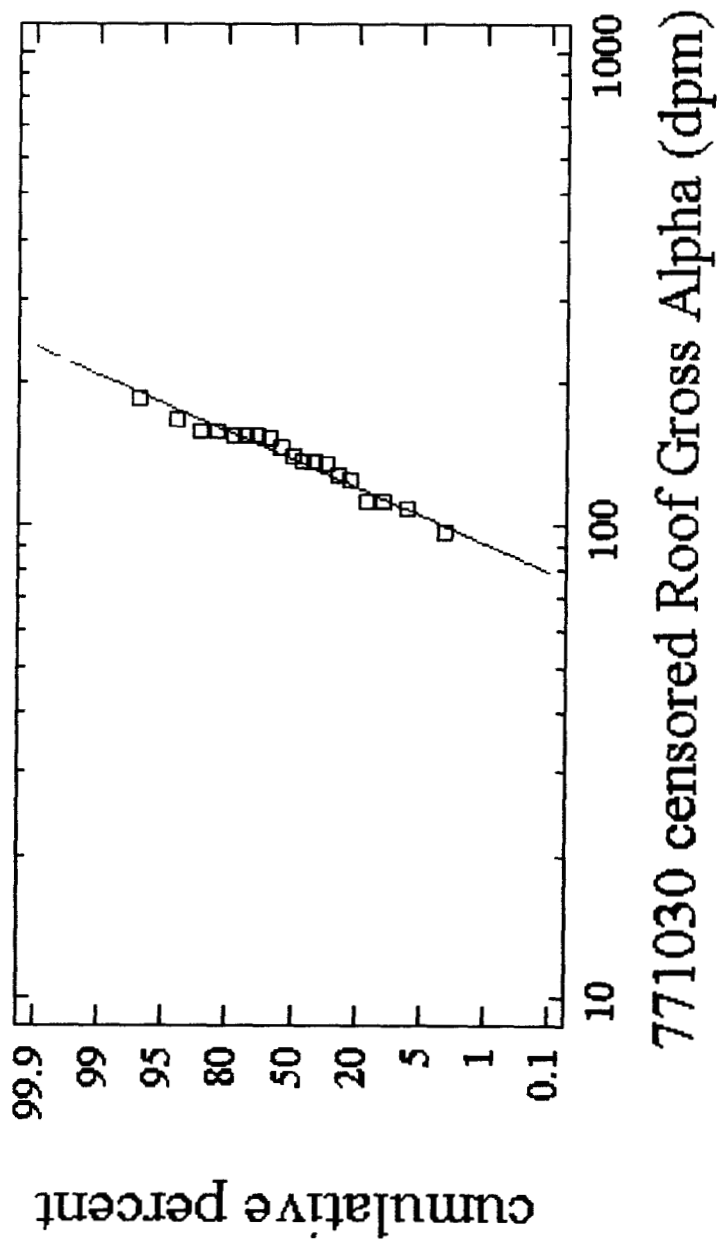
Lognormal Probability Plot

Since the smallest P-value amongst the tests performed is greater than or equal to 0.10, we can not reject the idea that 771030 Po210 Investigation comes from a lognormal distribution with 90+ or higher confidence

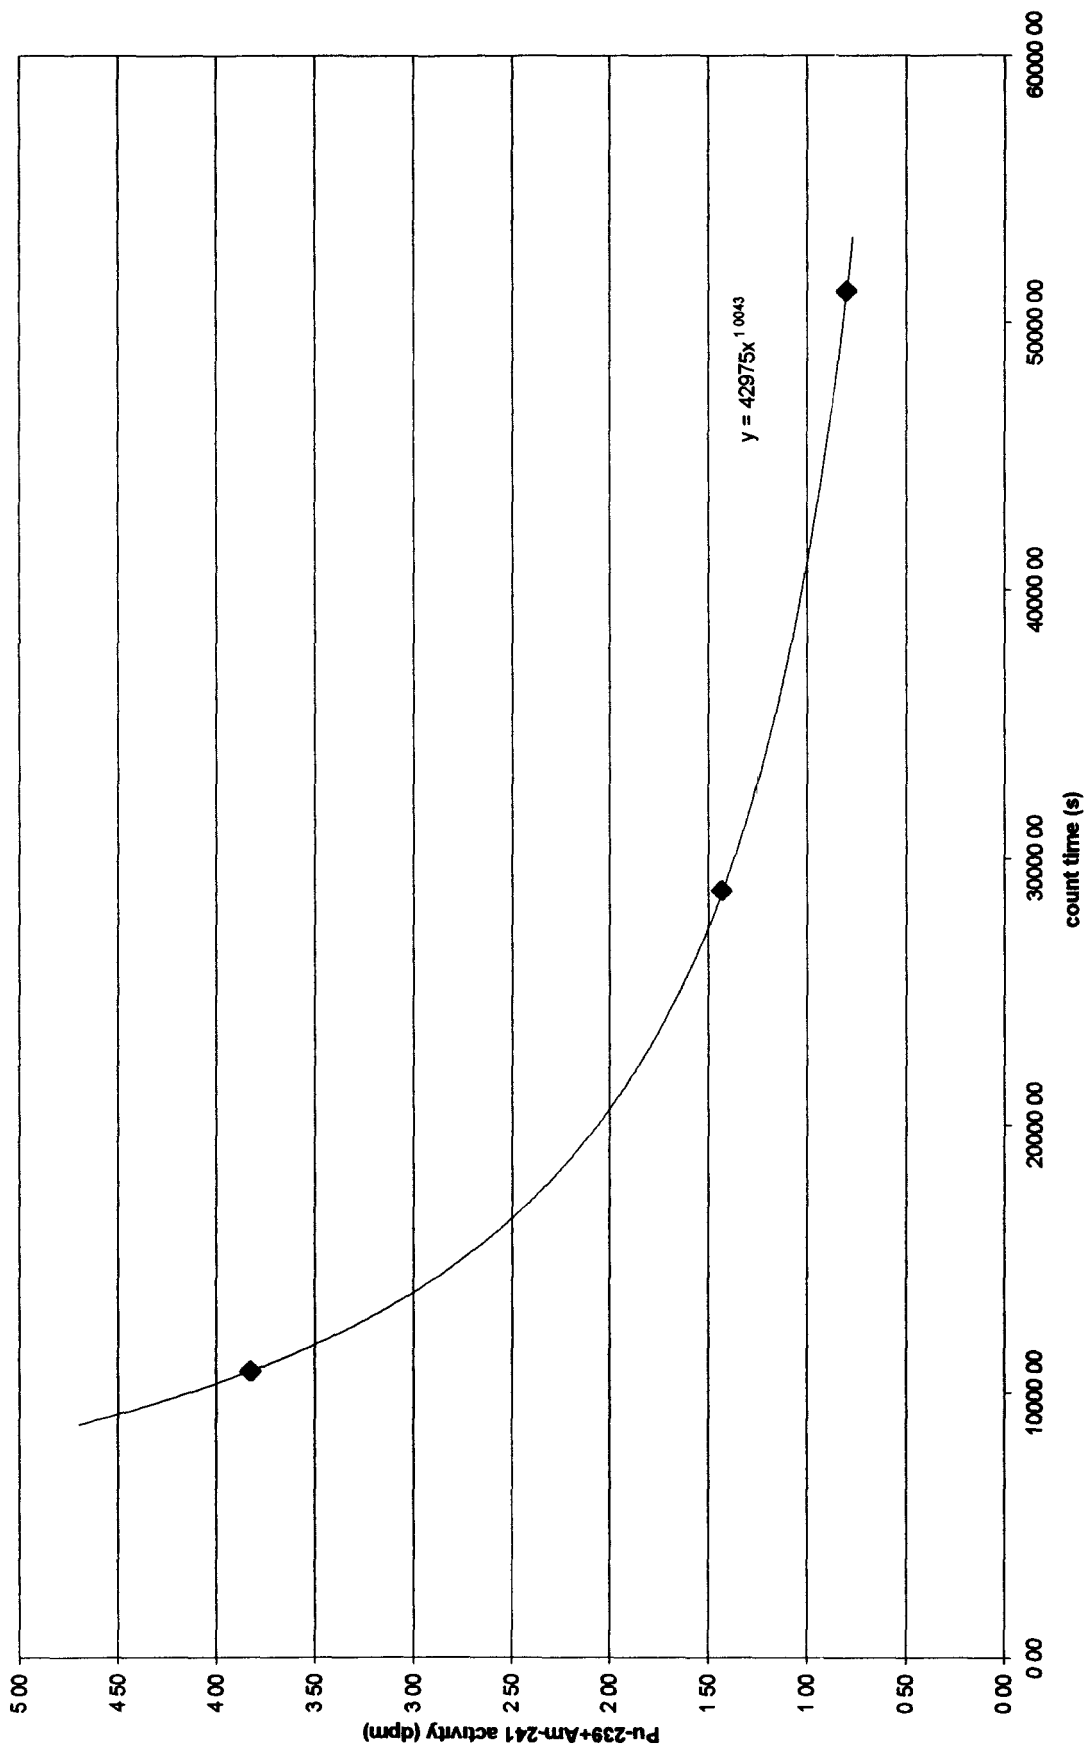
OASIS sensitivity estimates for 1-in roof coupons

| OASIS sensitivity in dpm/100cm ² for 1 79 -in roof coupons with a 7200 -s count time | | | |
